Manhole Inspection Summary

Manhole # S41W1_016MH

Location Address: **600 Maude Ave**

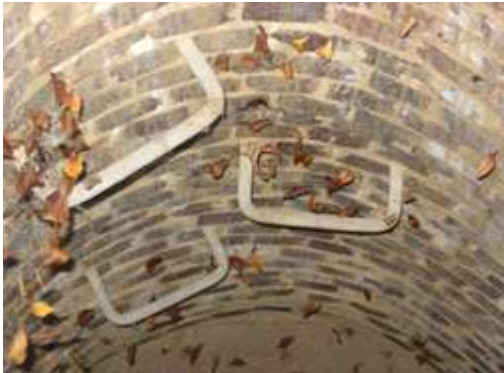
steps

Count: **3** Missing: **0** ☐ Corroded

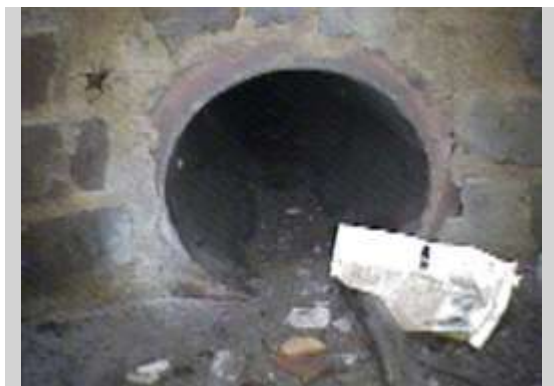
12 O'Clock Outflow

8 in. Circular Gravity Sewer
Pipe Out @ 12 O'Clock

Deposits: ☒ None ☐ Mud ☐ Sludge ☐ Debris ☐ Grease

Infiltration: **None** Pipe Seal Cond: **Sound**
